## 20 An ecophysiological framework for interpreting sap flow data

### 20.1 Example Sap Flow data and scenarios

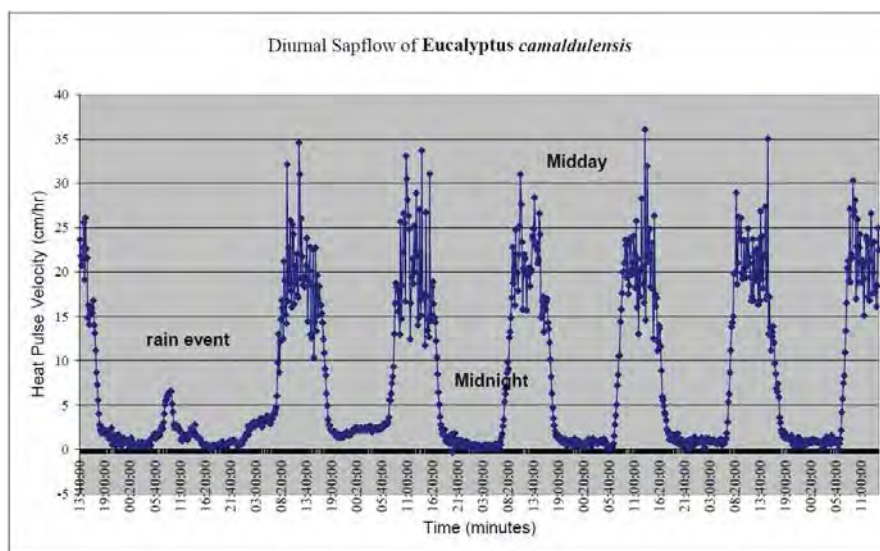
Figure 119: A typical diurnal heat pulse velocity pattern of a *Eucalyptus camaldulensis* with very 'clean' HRM data and no obvious problems; needles well in conducting sapwood over a period of 1 week. Zero flows are experienced at night time with fluctuating peaks throughout the day in response to changing light conditions and evaporative demand. In this example the effect of a rainfall event on sap flow can be clearly seen.

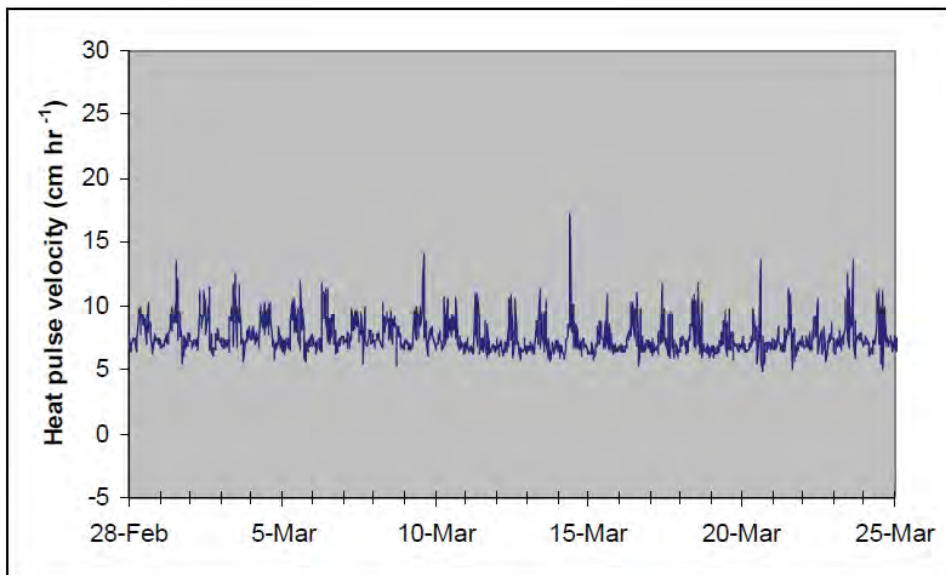
Figure 122: Data from a sensor that has been poorly installed such that one or more probes is badly out of alignment, resulting in an elevated (or decreased) baseline during periods of zero or near zero sap flow: The HRM has a provision to correct for bad probe spacing, but only to a certain extent (see Burgess et al. 2001). Nominally, probe spacing errors leading to baselines  $> +5$  or  $< -5$   $\text{cm hr}^{-1}$  cannot be corrected and reinstallation is necessary (such as in the case above).

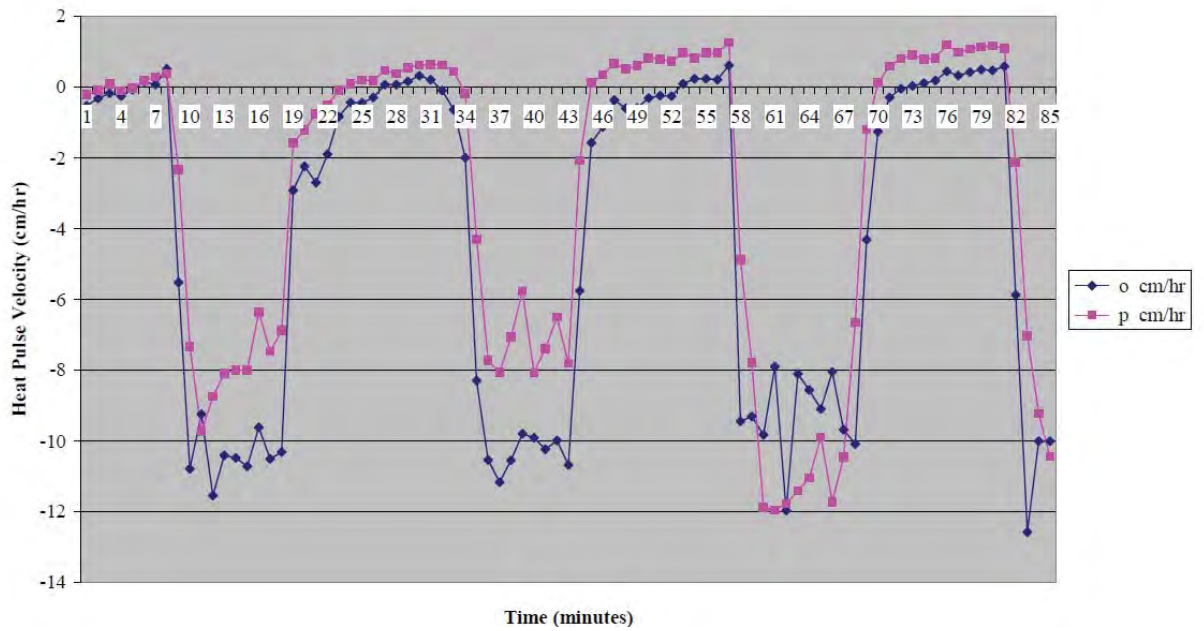
### HRM SVP10495 Address o & p

Figure 123: Example of HRM30 probes installed upside down. The diurnal pattern is correct except the values are negative. The upside down pattern is observed when the downstream temperature probe (black wire) is installed in the upstream position in the plant and vice versa. These problems are easily fixed, and furthermore, the data collected is not erroneous other than being inverted (also easy to fix as long as the user knows which way is up, particularly when working with roots!)
